OPERATION PLUMBBOB

NEVADA TEST SITE
MAY-OCTOBER 1957

Project 30.7

TEST OF GERMAN UNDERGROUND
PERSONNEL SHELTERS

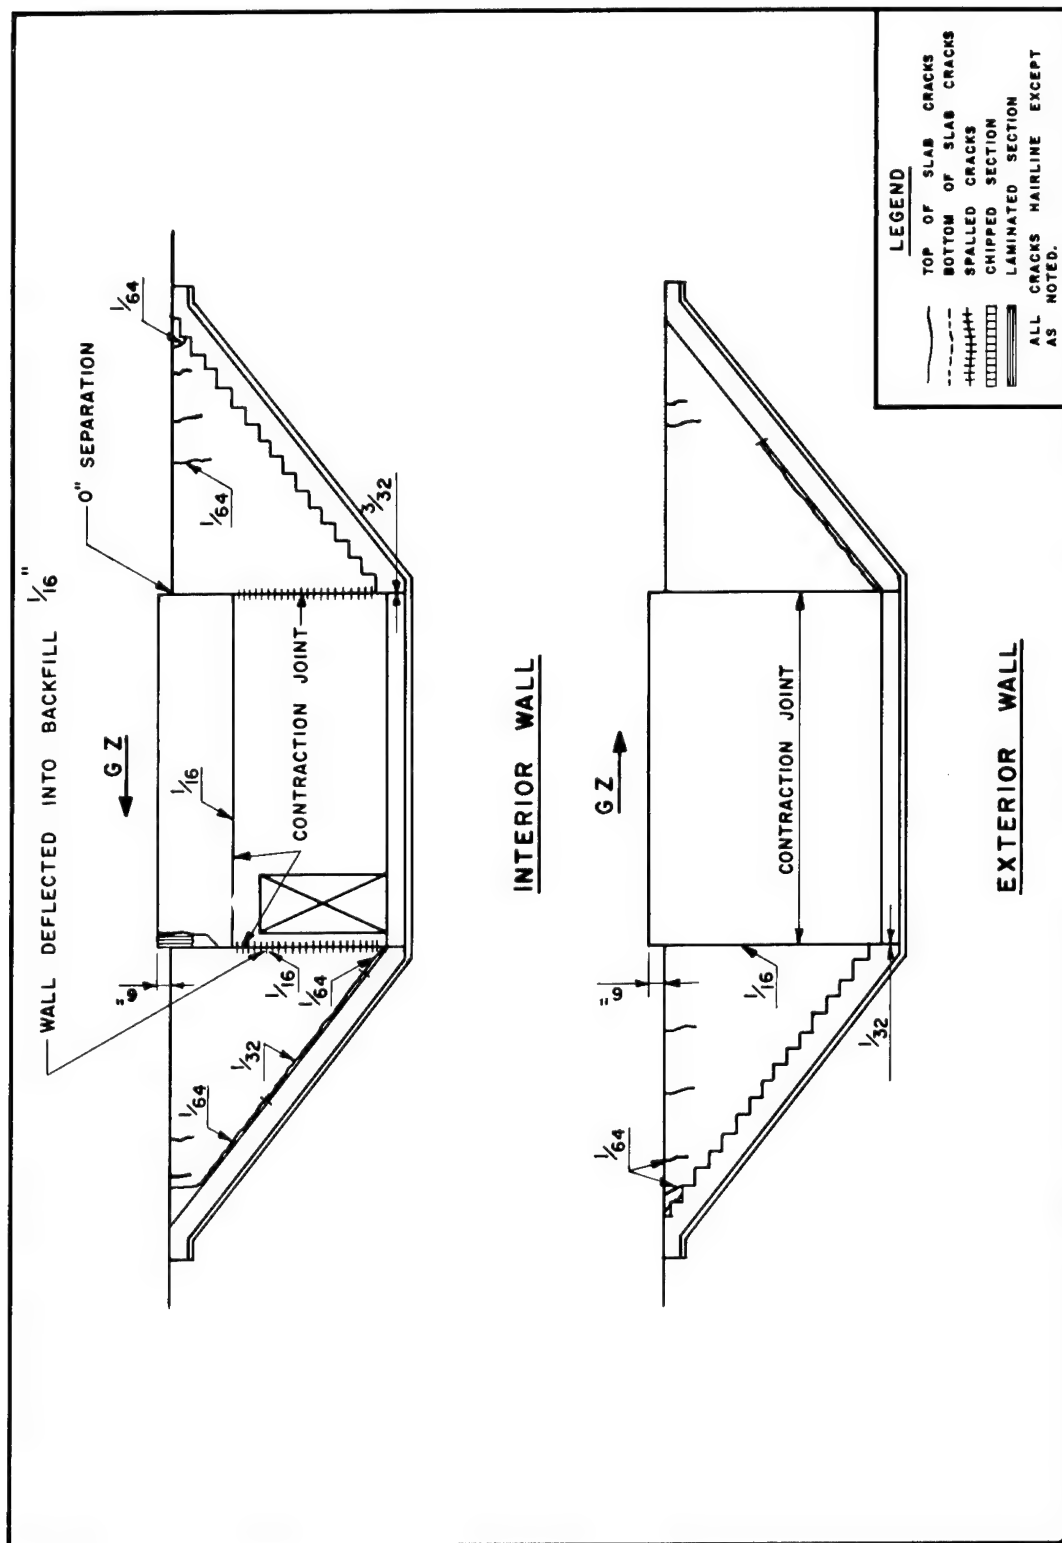
Fig. 3.84—Entrance crack pattern (structure RCa).

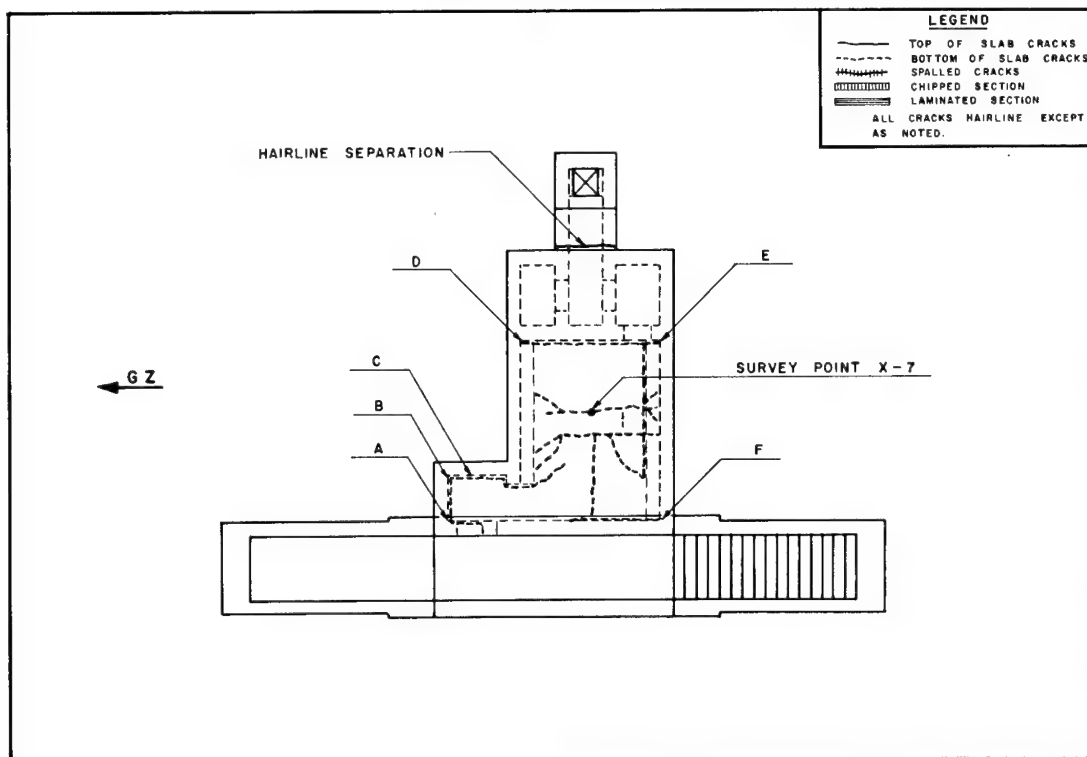
Fig. 3.92—Roof-slab crack pattern (structure RCb).

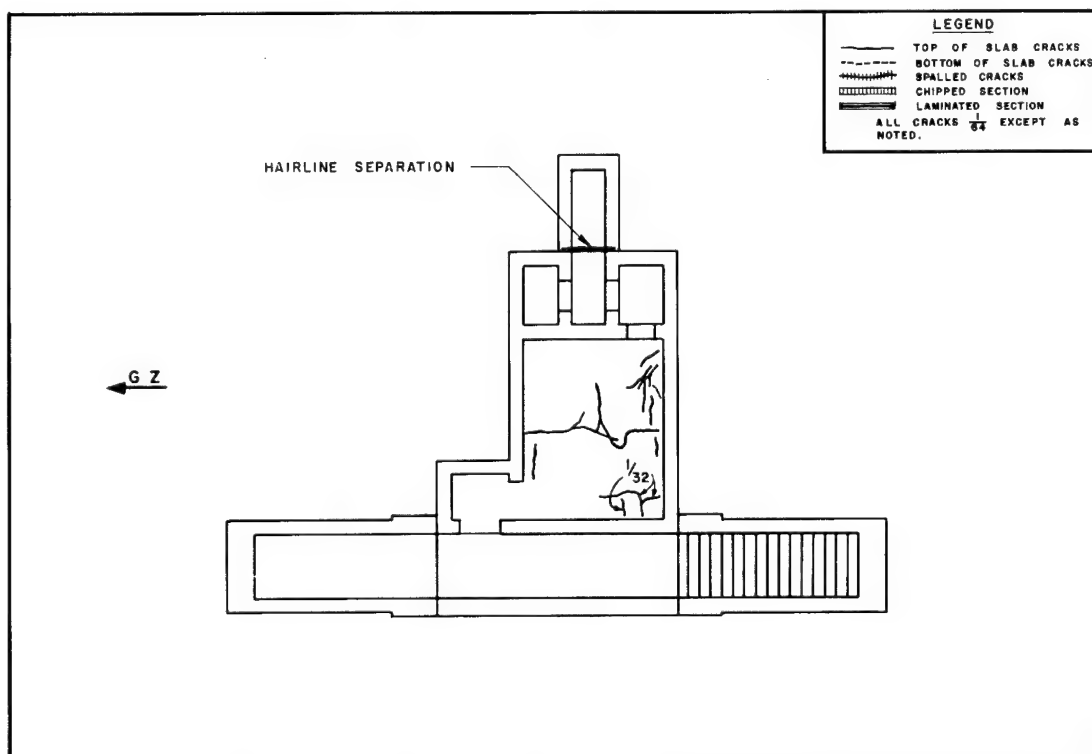
Fig. 3.93—Floor-slab crack pattern (structure RCb).

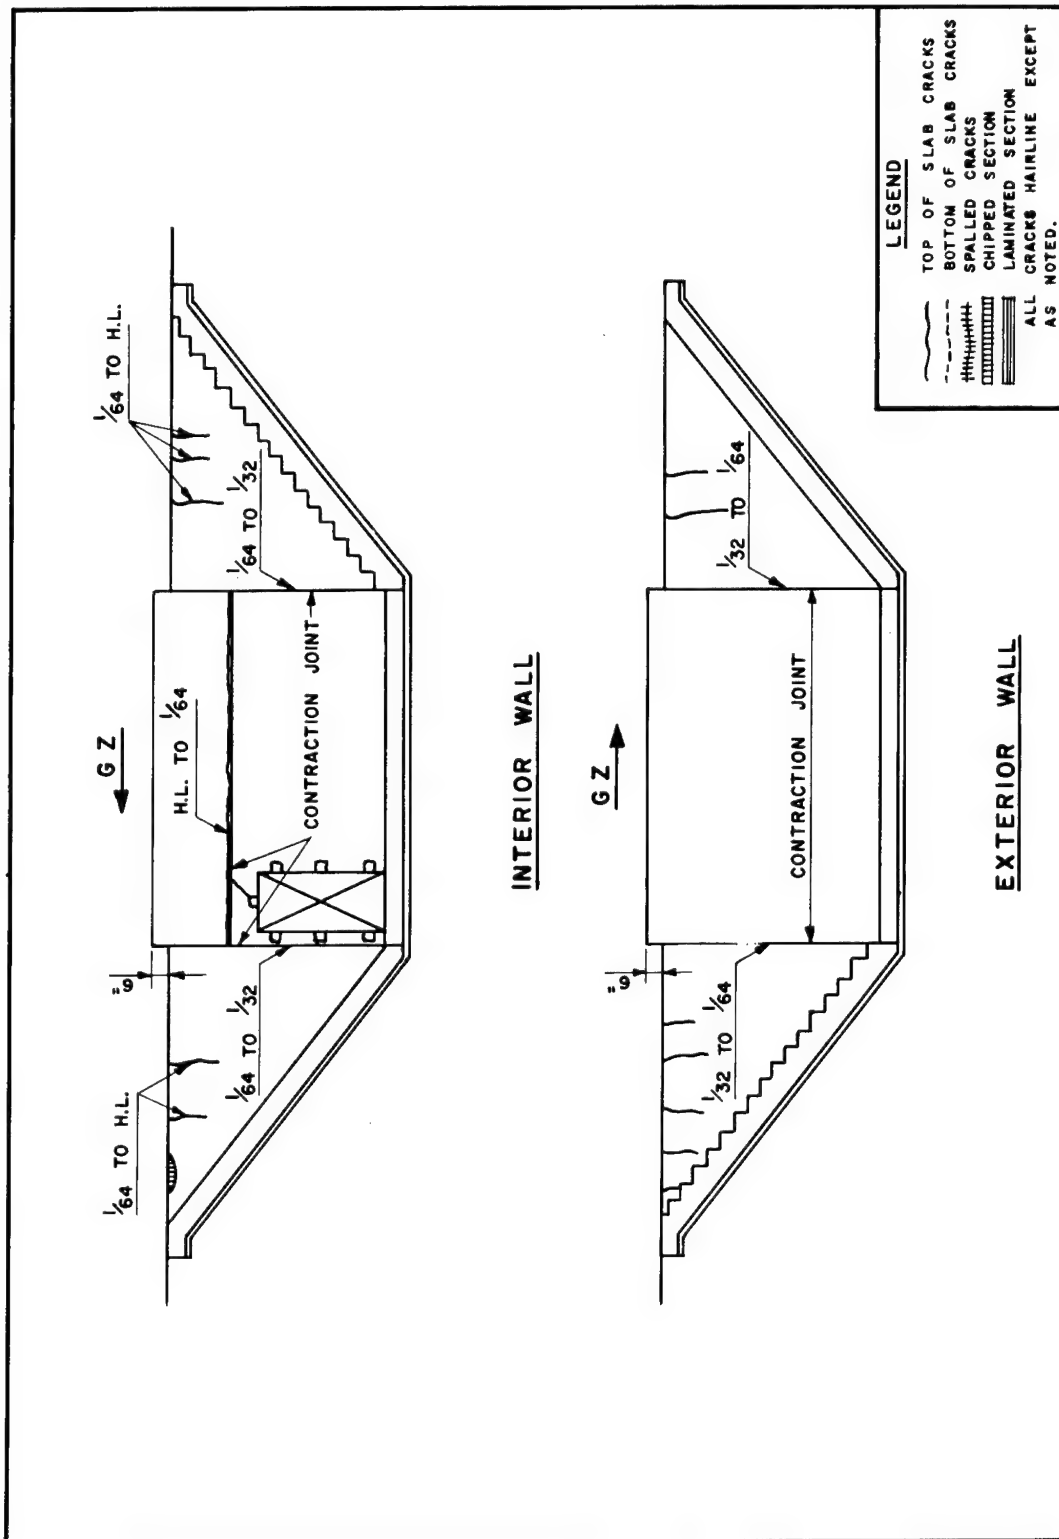
Fig. 3.94—Entrance crack pattern (structure RCb).

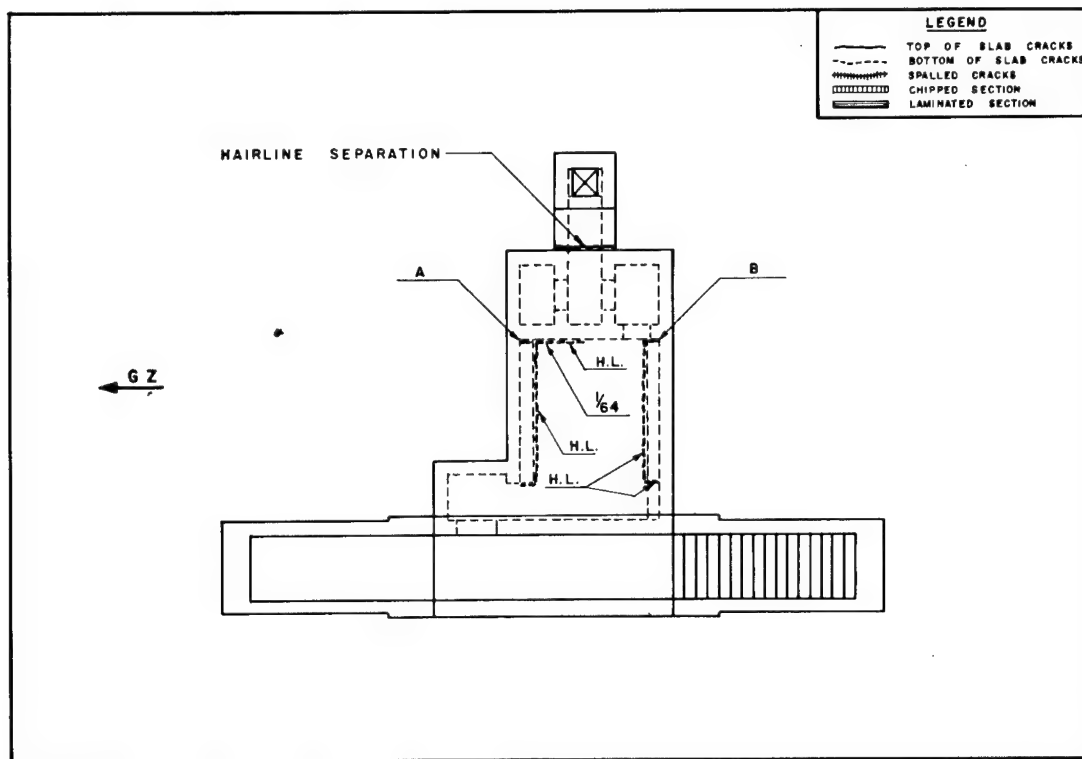
Fig. 3.99—Roof-slab crack pattern (structure RCc).

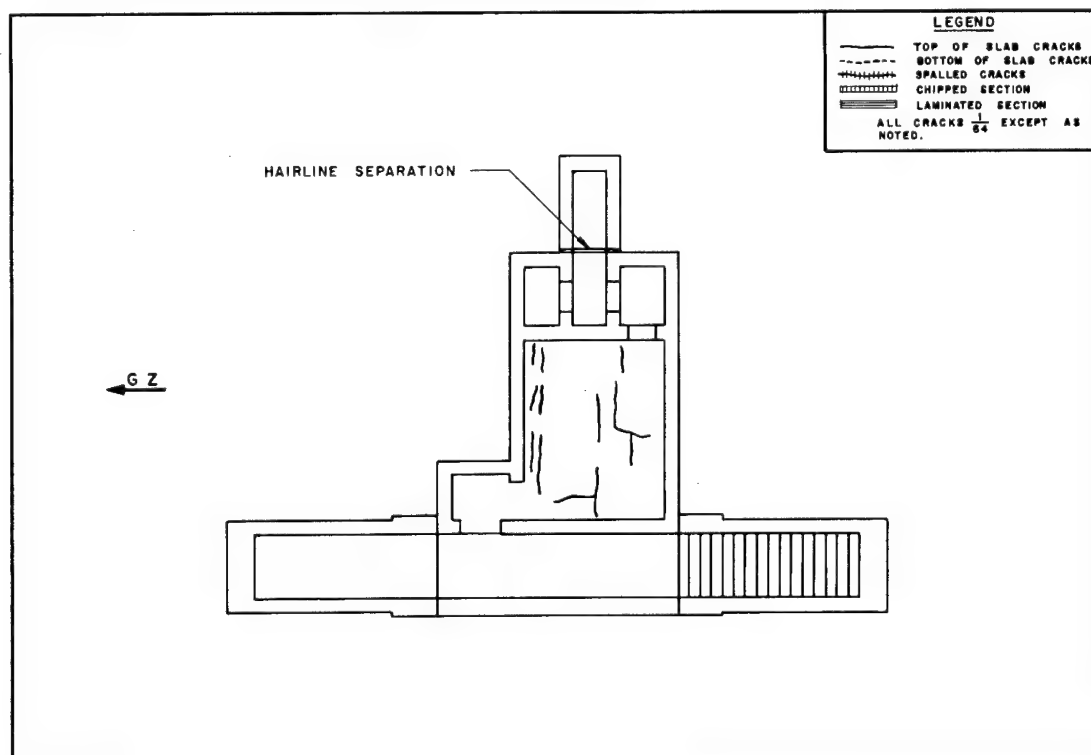
Fig. 3.100—Floor-slab crack pattern (structure RCc).

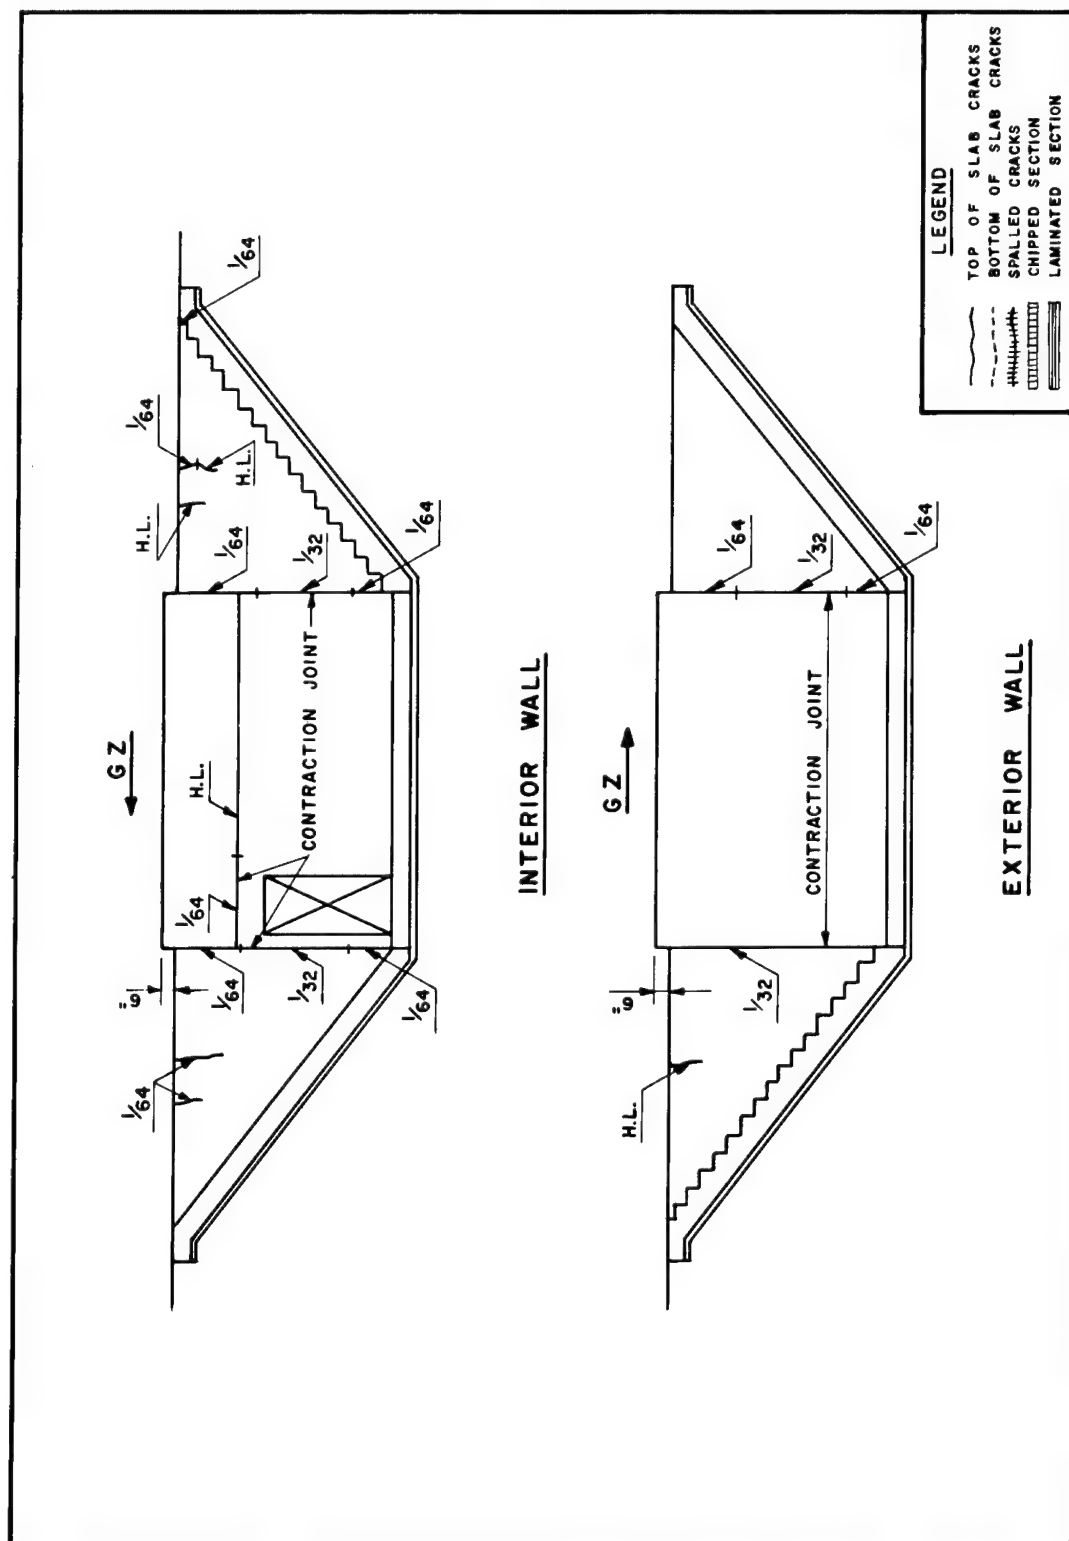
Fig. 3.101—Entrance crack pattern (structure RCc).
